REPORT

WATER POLLUTION SURVEY

THE COMMUNITY OF LAVIGNE
DISTRICT OF NIPISSING

DISTRICT ENGINEERS SECTION
SANITARY ENGINEERING BRANCH

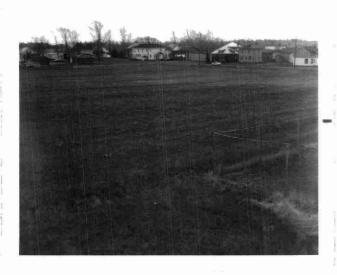
### Photo #2

The obvious sources of pollution in the area of Lavigne Creek are septic tank discharge pipes from homes and cabins on the banks of the creek. A four-inch diameter cast iron pipe carries the hotel's septic tank effluent to this creek. This location is displayed in the appended photograph, No. 2. It was evident from viewing several homes along this creek bank that sewage was discharging directly to the water. In the area of Caron Road and the small creek, there are two obvious discharge pipes. It is apparent that septic tank — tile bed systems do not operate successfully with the existing clay overburden.

Looking northwest from private bridge over Lavigne Creek. The effluent pipe (4" C.I.) from the hotel is evident in the centre of the photo (sample point #12). Other sewage effluents are hidden immediately to the right of the photo.

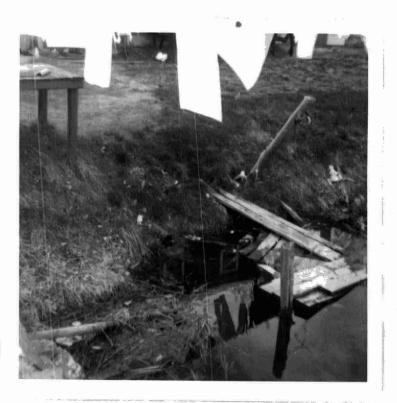
### Photo #3

Looking east from Highway #64 across
Lavigne Creek. Sewage from the building
immediately to the left is openly directed
to the creek with no apparent treatment.
The left cottage on far bank has just
received the repair and reconstruction
of the septic tank effluent pipe to the
creek. It is evident just below the
cottage. This method of disposal is
typical.

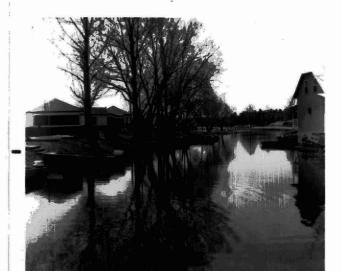
# Photo #5

Samples which were collected later on May 16. 1972 indicated faecal coliforms to be similarly present in all cases. Sample 6 contained extremely high faecal coliform counts of 3 million per 100 ml. This sample was collected from the 4-inch diameter A. C. pipe located on the north ditch on Caron Road just south-east of the public school. It is evident that this is the effluent pipe from the existing school's tile bed system. High concentrations of faecal coliforms were also present at Sample Point 4, 8 and 10. These examination results indicate that sewage is present in the ditches on Caron Road and in the creek adjacent to the public school and in all the areas of Lavigne Creek. A sample of Lavigne Creek at the mouth was collected for chemical analyses. The results indicate that the BOD at this location was 30 ppm which far exceeds the generally accepted range for surface waters; the BOD of natural water is usually below 4 ppm. Phosphorus and nitrogen concentrations were found to be high at points 3 and 8. The generally accepted maximum limit for these parameters are 0.02 ppm and 0.5 ppm respectively for natural surface waters. These increased concentrations of nutrients indicate that sewage is gaining access to the watercourse.

Looking northwest from Caron Road at the public school. The 4" diameter asbestos concrete pipe (sample location #6) is evident at the lower left. This is reportedly septic tank effluent. The creek is immediately below the photo.

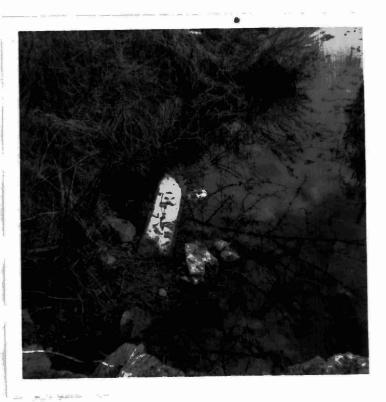
### Photo #4

Looking south from private bridge towards Northwest Bay. This picture portrays the recreational activity in the area. None of the residences in this picture have adequate sewage disposal systems. The building on the right discharges sewage directly to the creek (Standard cast iron sewage pipe can be seen at the base of the building).

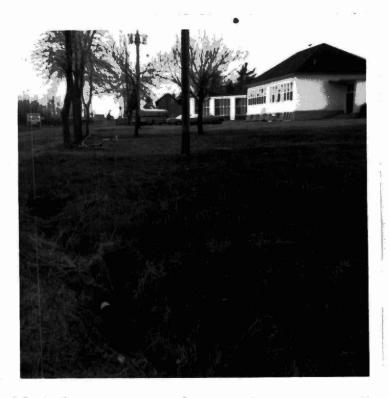
## Photo #6

The chemical analyses of the discharge sample collected at the ditch south of Caron Road (7) indicates both a BOD (biochemical oxygen demand) and suspended solids concentration of 60 ppm which far exceeds this Ministry's objectives for surface waters. Analyses results of the effluent sample from the hotel indicate a similar condition. Bacteriological examination

Looking southeast from Caron Road at the Creek. Sewage effluent is evident from centre of photo (sample location #7) and runs south towards Northwest Bay.
